**A National Monitoring and Evaluation Agency  
(NaMEA)**

**Monitoring Report**

***Growth for Peace Consolidation and Youth Empowerment  
(GPCYE) Project***

DECEMBER, 2025

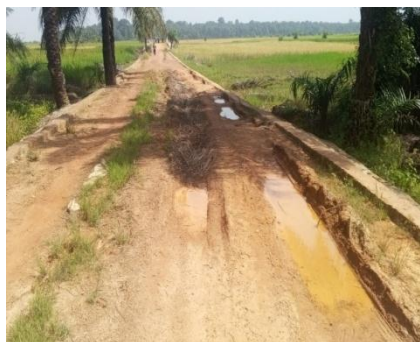
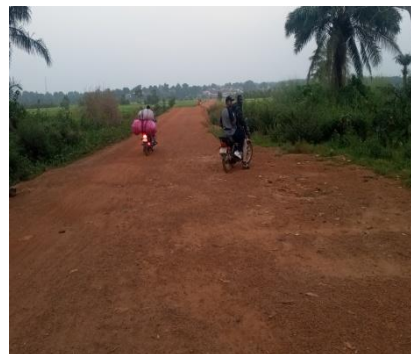
All these feeder roads were generally found to be in good shape. However, desilting of side drainages and proper backfilling at culvert edges are required to ensure durability and safety.

Macoth-Rokel Feeder Road    Kobia Jnc-Robis Road

Rokon-Rokon Wharf Road

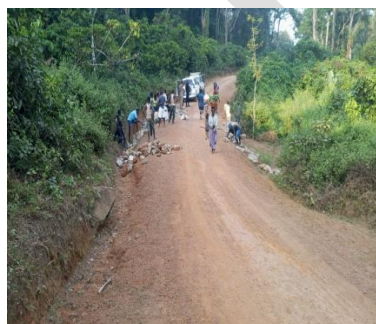
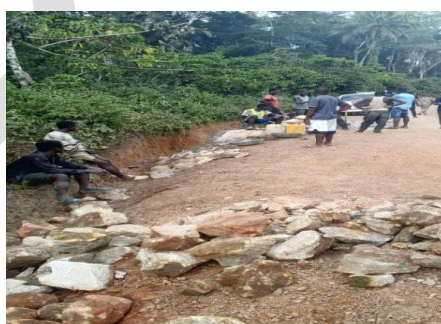
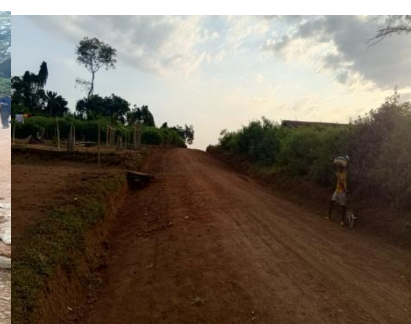
- Desilting and increased depth of side drainages, and improvement of camber work.
- Inadequate culvert spans for approaching vehicles, especially where two vehicles may meet at culverts.
- Need for proper backfilling of culverts to match slope and width of the feeder road.
- Some stretches are too steep or hilly, resulting in uncomfortable and potentially unsafe travel.
- The cement mix at the joints of stone-pitched areas must be strengthened.

Stone-Pitching along Segments 1&2

Road Stretch: Yardu-Kondeya Line

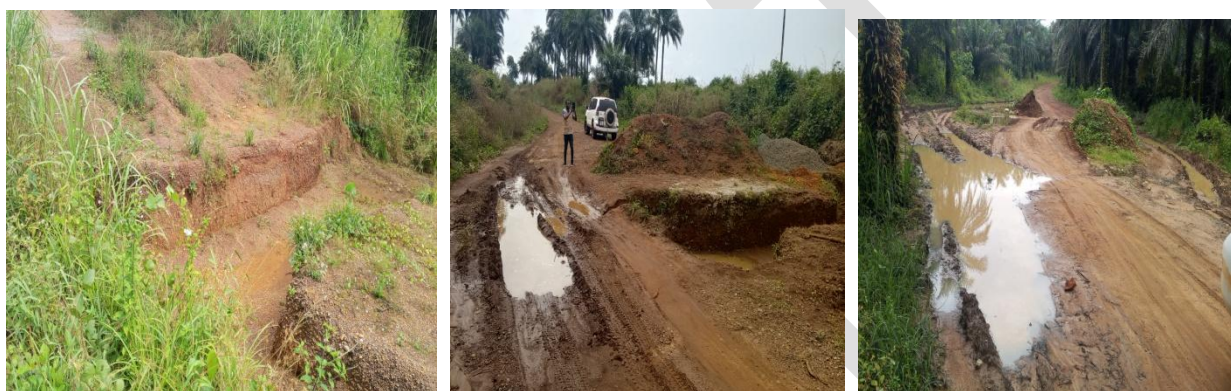
*Segment 1 Madina – Ngaypayhun route*

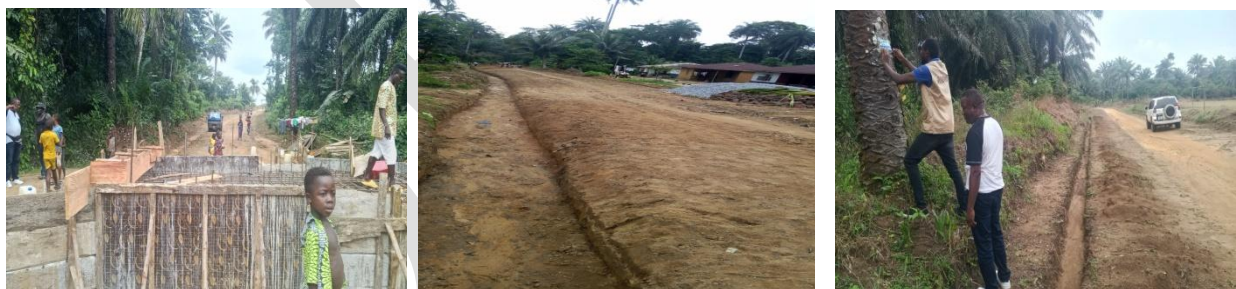
Sogbaleh – Bissao (Tomando) Madina – Senehun

Sogbaleh – Bengkeh

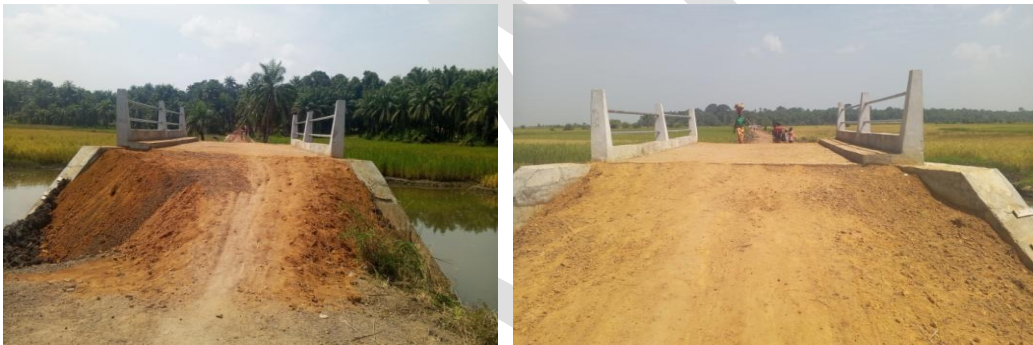
*8 meters length bridge (KAM 06 2025)*

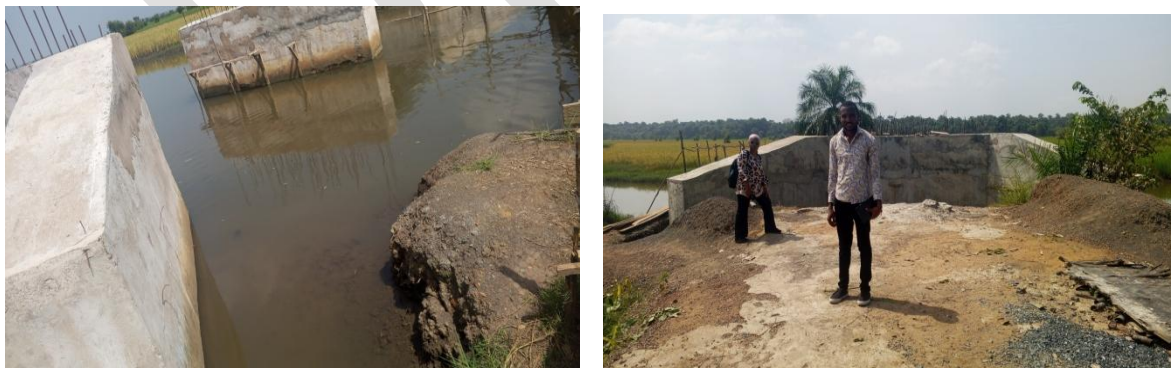
*15 meters length bridge (KAM 05 2025)*

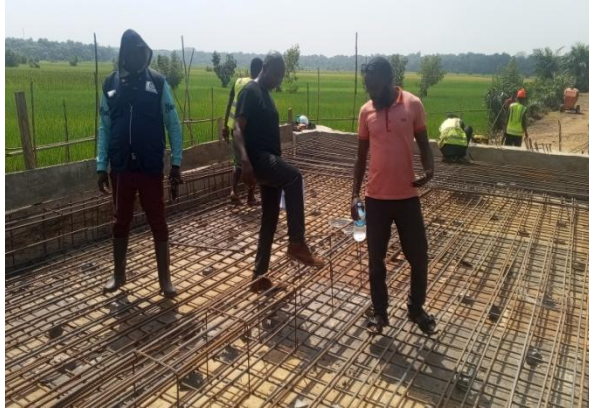
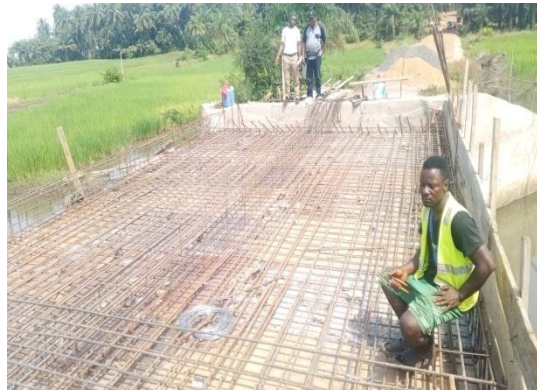
- a) The bridge is under construction; both abutments and the centre pier have been constructed, but the slab has not yet been concreted.
- b) Exposed shoot-out reinforcements for the slab are beginning to corrode and require protection.
- c) The waterway beneath the abutments, wing walls and centre pier is sufficient

8 meters length bridge (KAM 04 2025), under construction

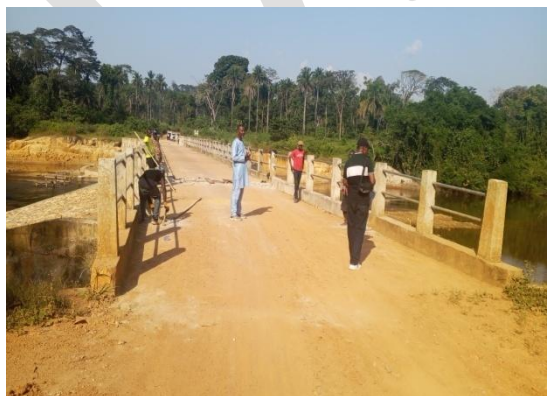
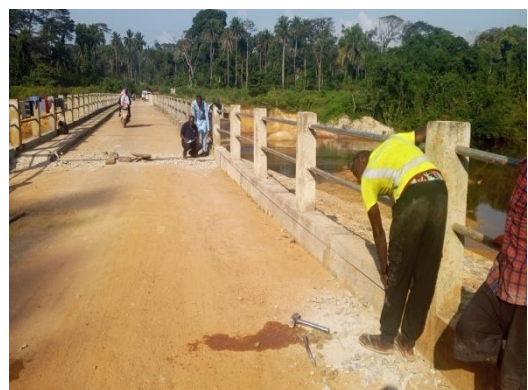
- a) The bridge was initially completed and is within its six-month defect liability period. The initial contract span was 43.15 metres, but this was later extended by 21.5 metres to improve the clear waterway, resulting in a total length of 64.65 metres and a width of 6 metres.
- b) Additional works underway include: construction of two relief culverts at both ends of the bridge; strong retaining walls and embankments; expansion joints; and pavement works at the approaches.
- c) The reinforced deck concrete is generally even, but a crack was observed in the pavement area. The contractor was on site carrying out remedial works. Railings are being installed and appear strong.

All structural components observed appear to be properly cast and firmly in position.

*The Yikuma Crossing Bridge (Sandor Chiefdom, Kono District)*

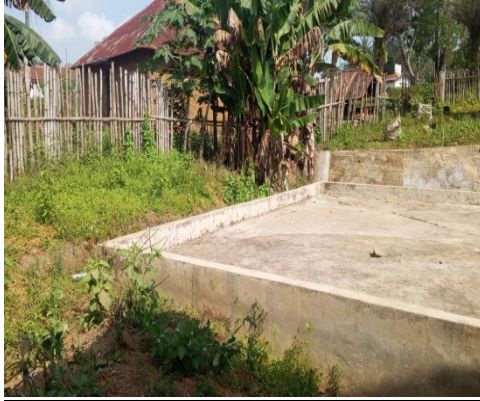
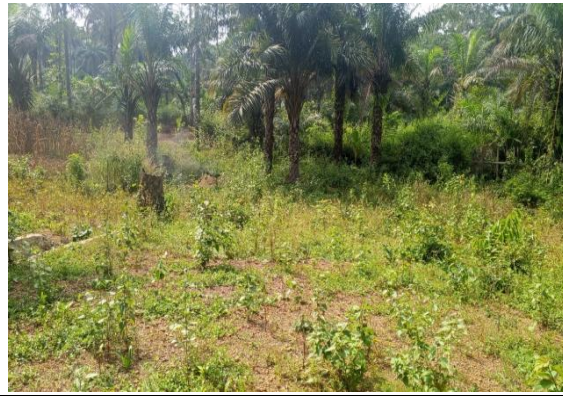
- a) *The grain store and ancillaries* have been handed over, and a Certificate of Final Completion (COFC) has been issued for both milling and destoning machines.
- b) *Destoning machine*: Missing fan belt and fuel tank cover.
- c) *Drying floor*: Same issues as in Mahera (rough finish, cracks, insufficient slope and problematic diagonal slots).
- d) *Borehole and water system*: Leakages observed at piping joints.
- e) *General environment*: Most of the perimeter fence has collapsed; the compound is bushy inside and outside the fence

*Rough dry floor slab; Bushy grain store compound (Wulanthenki, Magbema Chiefdom)*

- a) Require contractors to correct all identified technical errors and defects across roads, bridges, grain stores, boreholes and ancillary facilities. Most apparent is the grain floor. Ensure that all drying floors are reconstructed or rehabilitated where necessary to prevent cracking and to achieve adequate slope and drainage without the need for diagonal channels.
- b) Bore holes in Peyima and Yardu-Kpendema Sandor are not operational because several drilling attempts did not yield water. We recommend that contractors should trace water

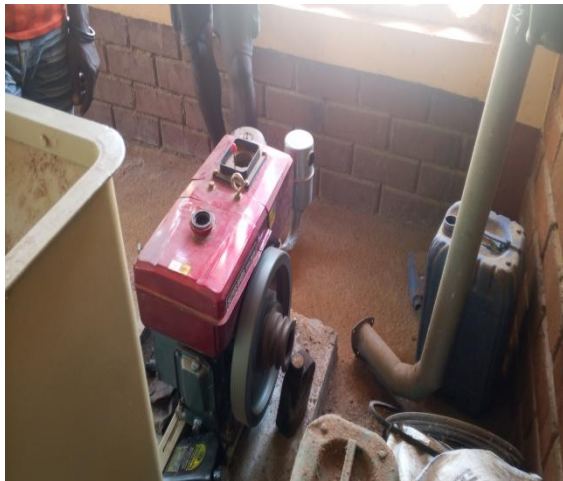
*No fan belt & cover for destoner; Leakage in borehole piping (Wulanthenki, Magbema Chiefdom)*

- a) Provide weighing scales in all grain stores to facilitate accurate measurement and transparent management of produce.
- b) Ensure timely repair or replacement of non-functional milling and destoning machines, with clear allocation of responsibility and costs.
- c) Resolve borehole problems, including the salty water issue in Mahera (Kambia District) and the unsuccessful drilling attempts in Yardu-Kpendema Sandor (Kono District), through appropriate hydrogeological assessment and remedial action.
- d) Complete installation of solar panels, piping and water tanks in Peyima (Kono District) and other partially completed water systems.

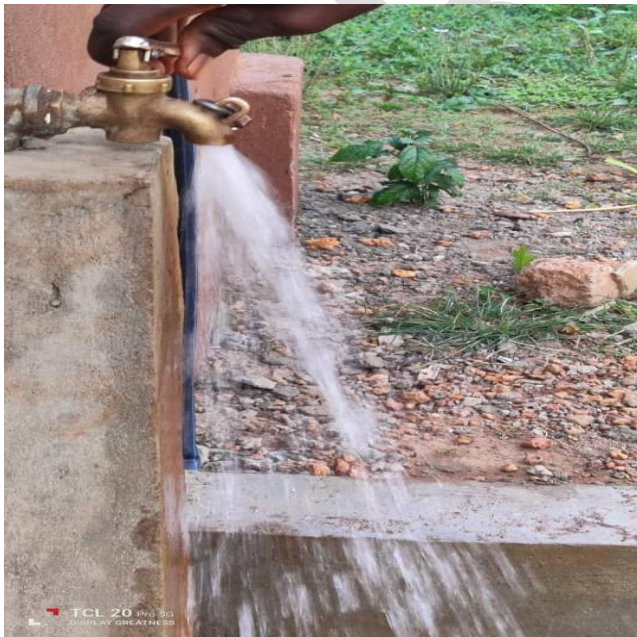
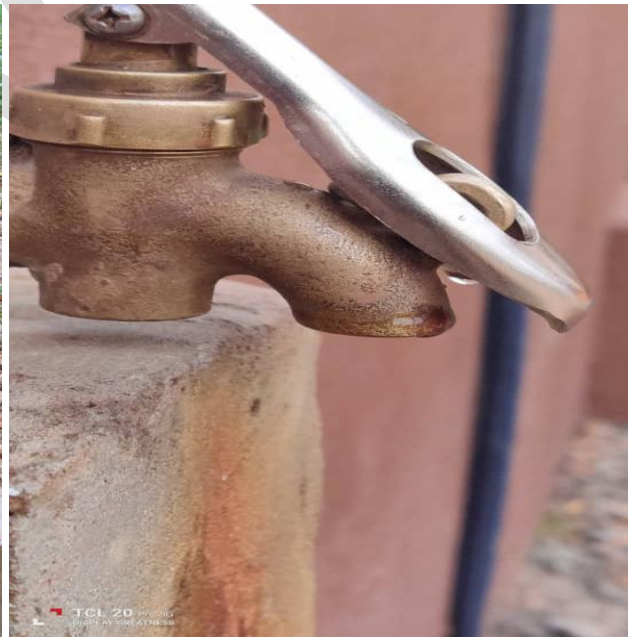
- a) *Grain store and ancillaries* are well constructed and maintained by the FMC
- b) Community taps are working
- c) The tap system (water collecting point) under the main tanks in the compound is not properly done. The tap head is too close to the pipe encasement, not protruding at a length to comfortably place a bucket to collect water.
- d) *Drying floor*: Similar technical issues with rough finish, cracks and inadequate drainage slope.
- e) *General environment*: The facility is kept clean.

*Water Collection Point (Rokon Village, Samu Chiefdom, Kambia District)*

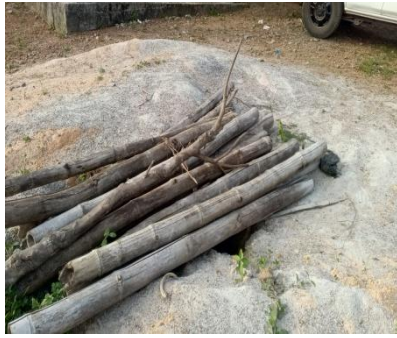
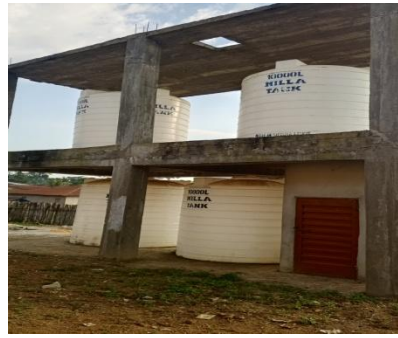
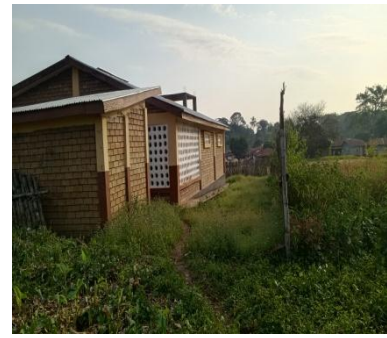
- a) *Grain store*: Constructed and functional.
- b) *Milling machine*: Available and working.
- c) *Solar facility*: Installed and functioning.
- d) *Drying floor*: Same technical issues as in Kambia (rough finish, cracks, inadequate slope and problematic diagonal slots).
- e) *Borehole system*: Three different drilling attempts in the vicinity of the grain store have failed to yield water; therefore, the borehole is non-operational. Four 10,000-litre tanks are installed on two towers (two per tower).
- f) *VIP latrine*: Constructed but not in use because the site foreman left with the keys and cannot be reached. NaCSA's district office should follow up.
- g) *General environment*: Most of the perimeter fence has collapsed and the compound is bushy and poorly maintained.

*Current status of borehole, supply pipes and bushy site at Yardu-Kpendema-Sandor grain store (Sandor Chiefdom, Kono District)*
